THE CALIFORNIA EARTHQUAKE OF APRIL 18, 1906

STATE EARTHQUAKE INVESTIGATION COMMISSION

VOLUME I, PART II

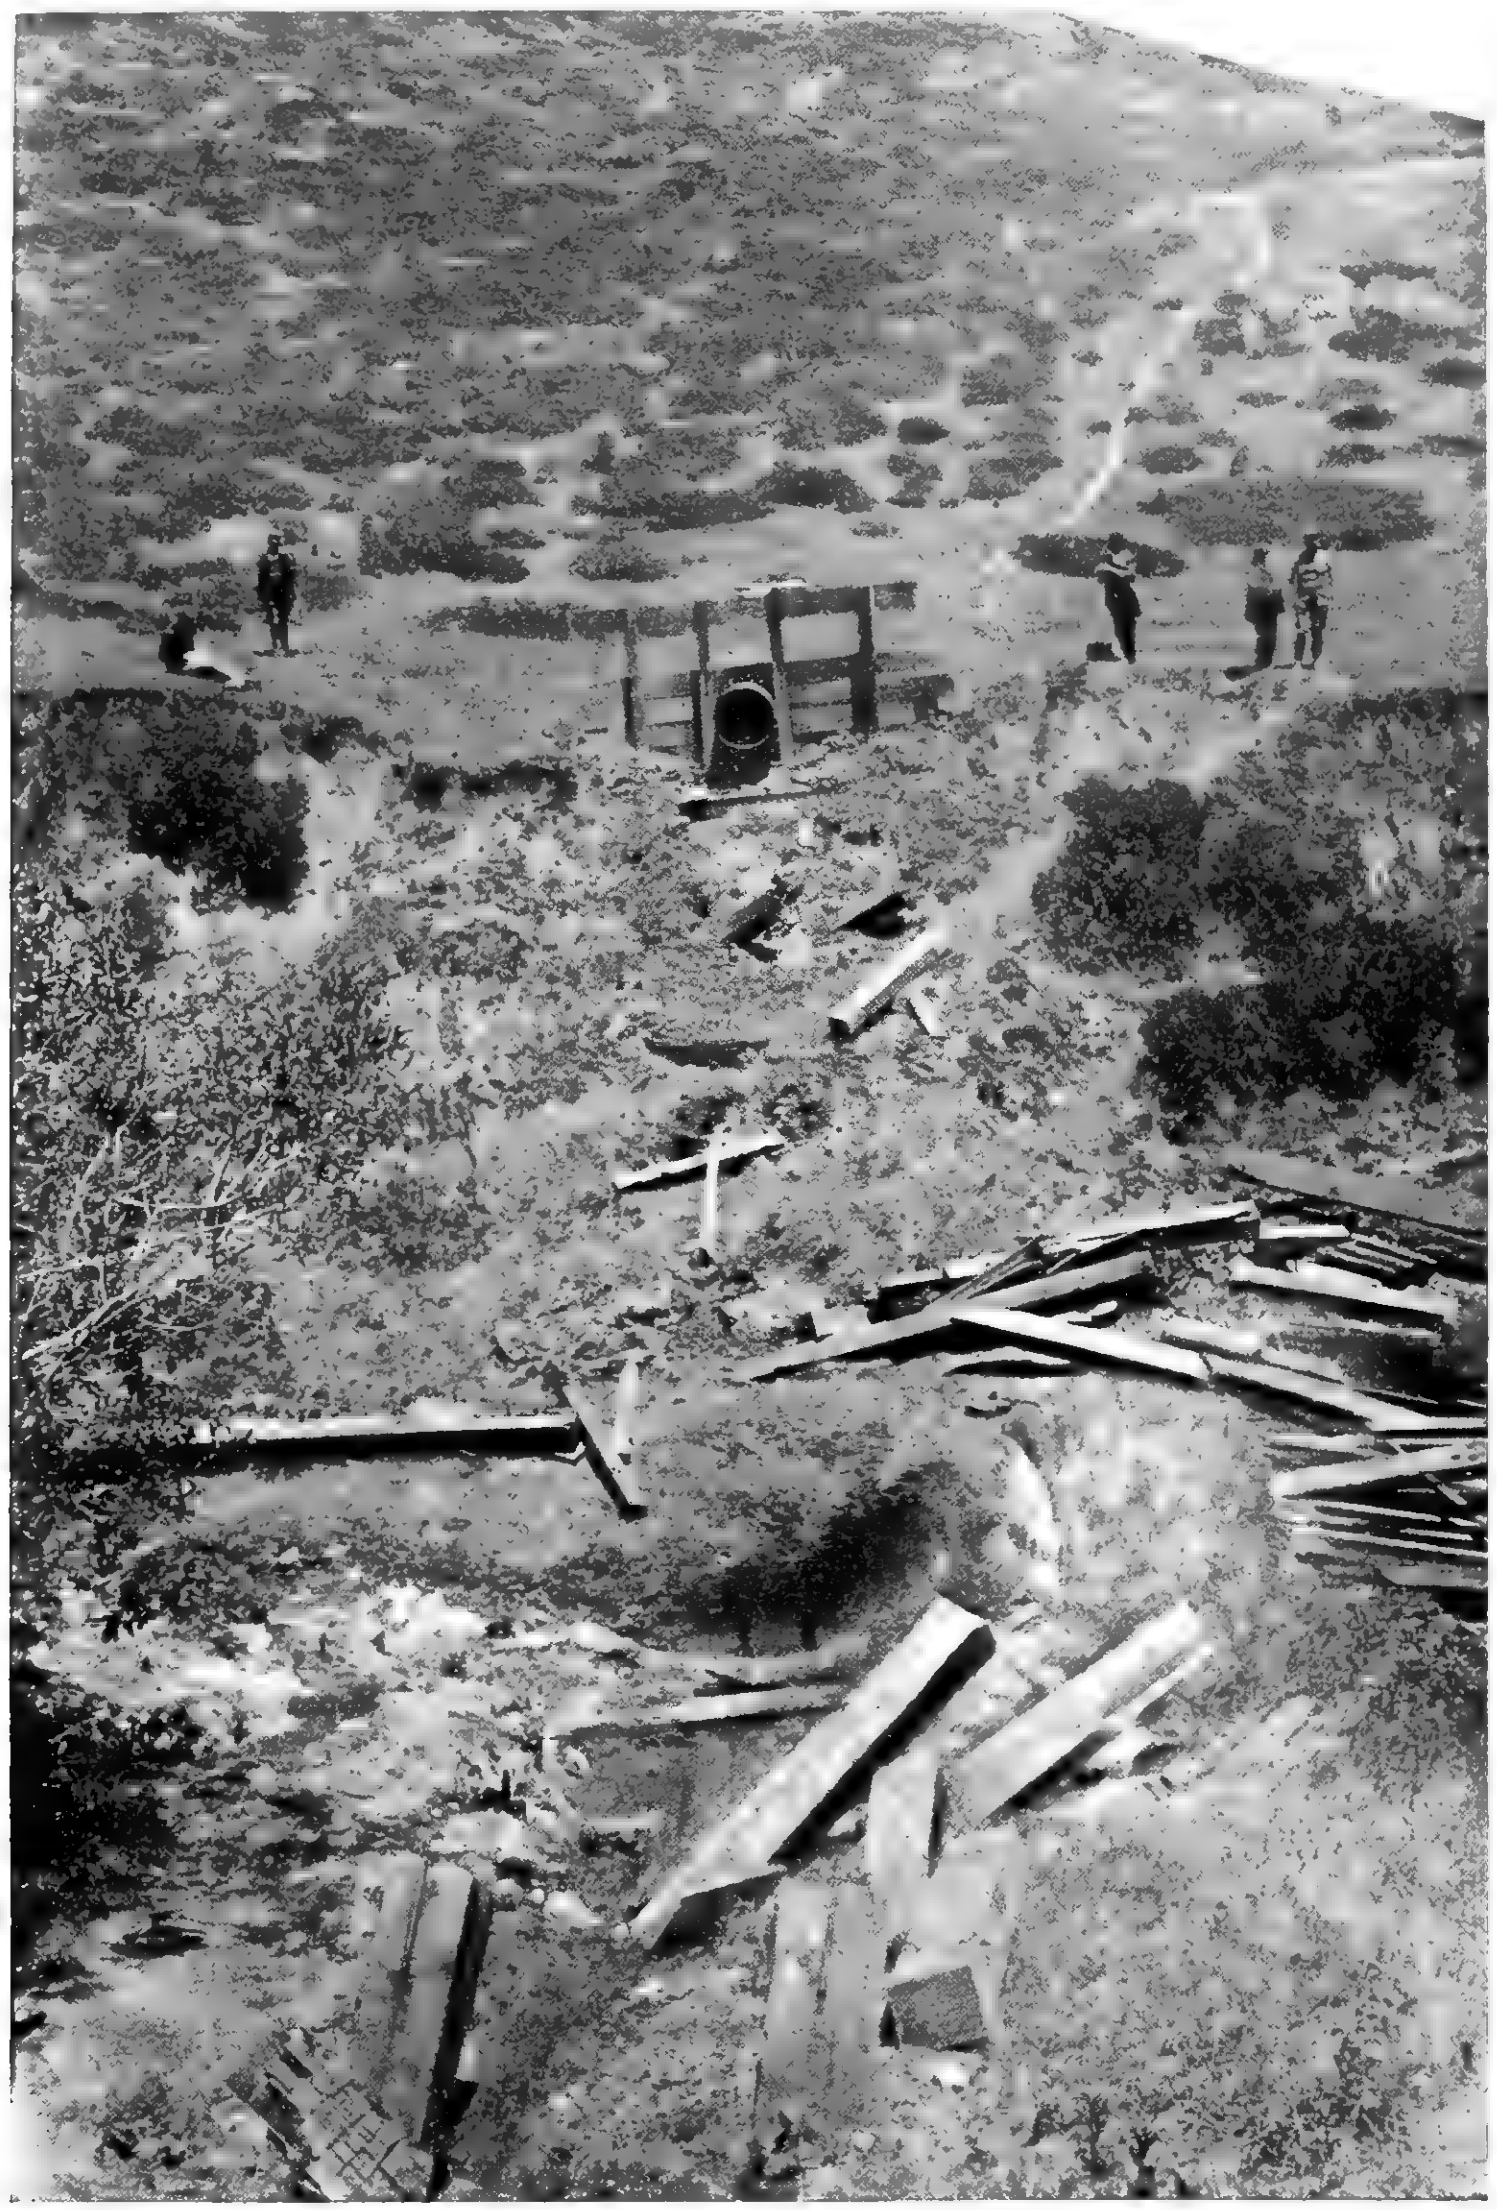
B. Wreck of 2-story brick building, San Mateo. Per J. C. B.

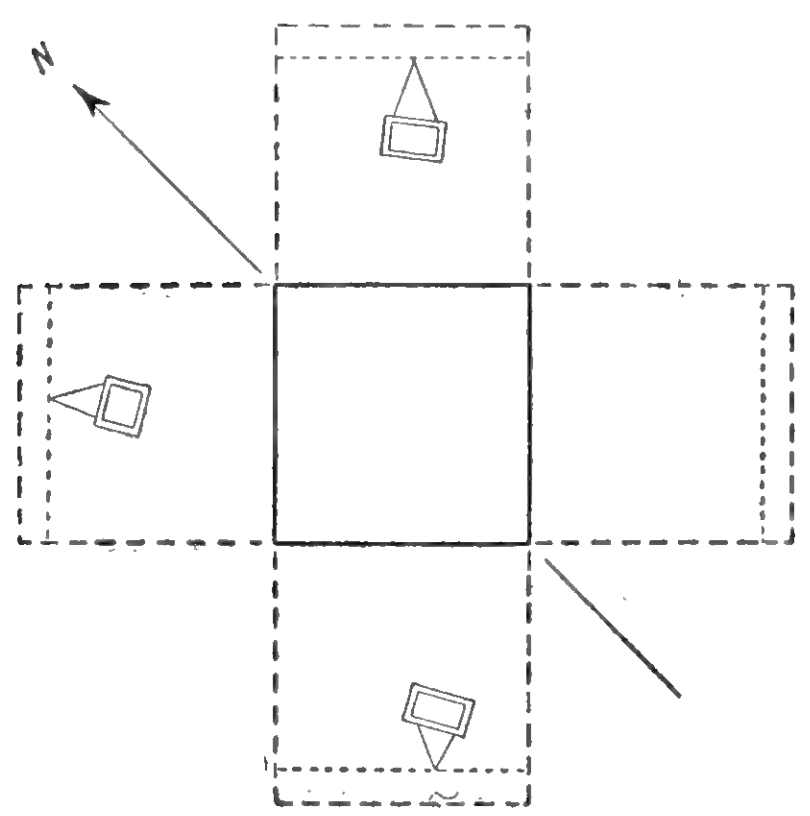
1110 Bryant: Small one-story frame house; chimney at center of house twisted slightly counter-clockwise.
121 Emerson: Small one-story frame house; chimney in center twisted clockwise.
Waverly near Lytton: The Palo Alto Academy, an old two-story frame house, completely collapsed, falling toward the southeast and apparently twisted counter-clockwise.
Emerson, near University Ave.: Two-story frame house was moved off its foundation toward the southeast, and twisted clockwise.
711 Cowper: Pictures on walls; some remained straight, others were twisted as shown in the sketch, showing the four walls of the room. The pictures on the northeast and southwest walls were observed in one room and those on the northwest wall in another room. (See fig. 55.)

Fig. 55.—Diagram showing displacement of pictures on walls of rooms.

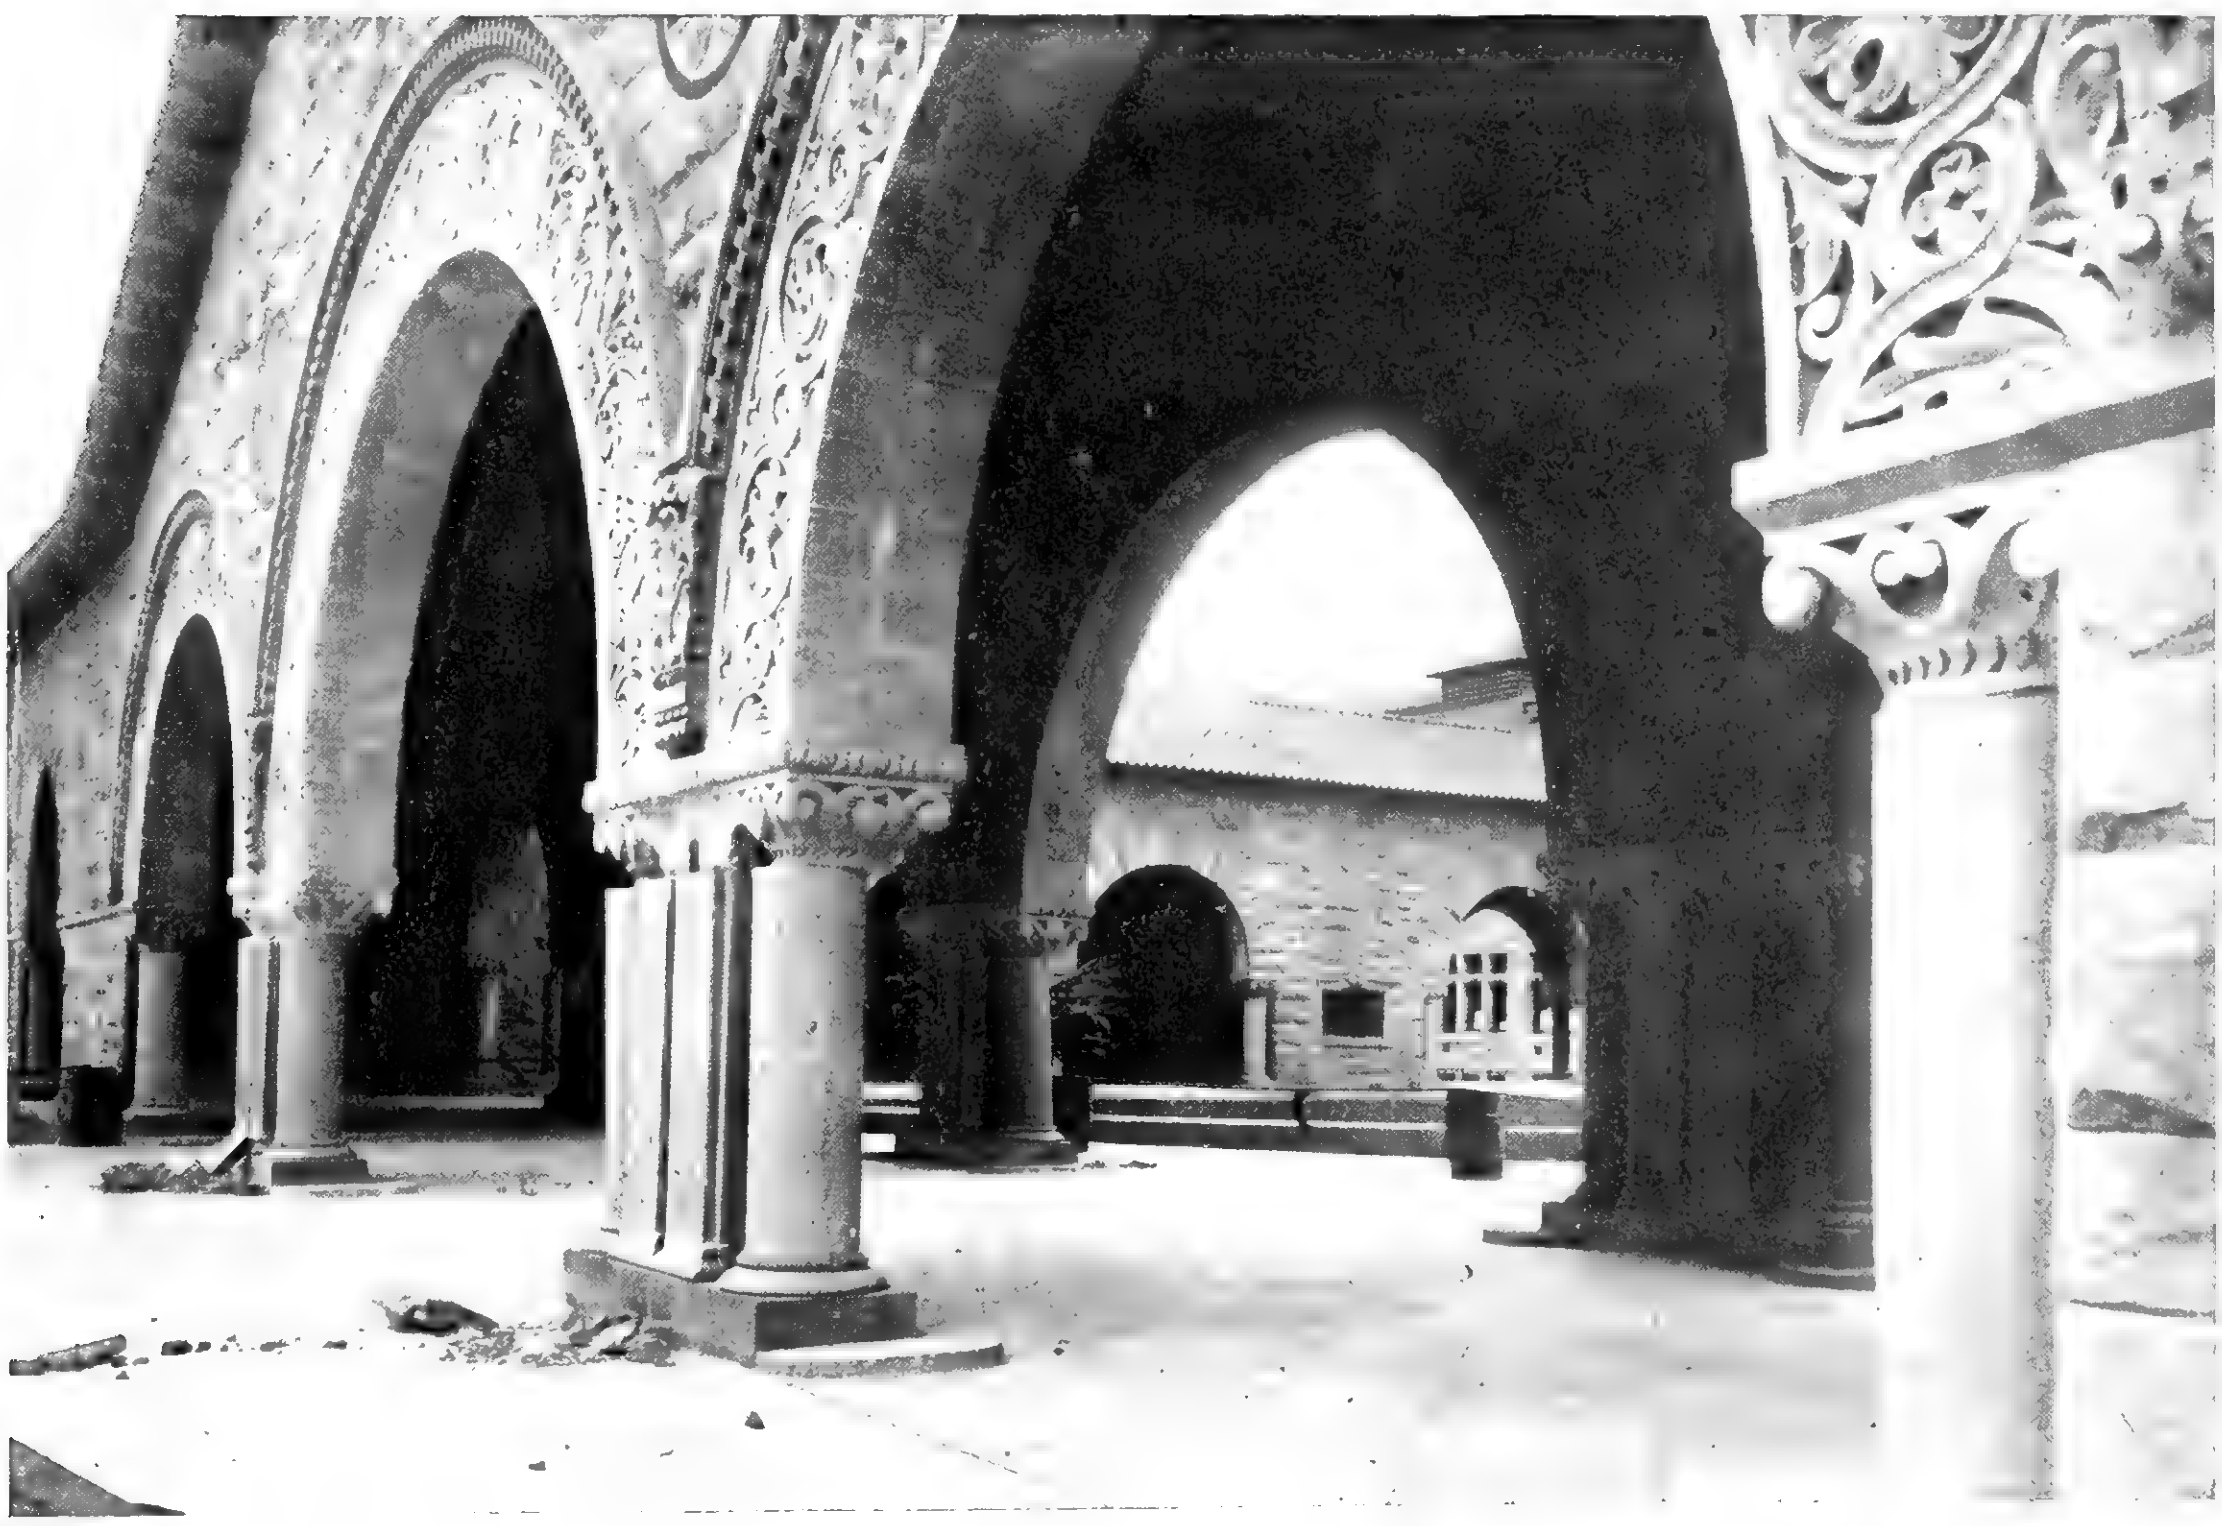
The Geology building, at the southwest corner of the outer quadrangle, was the last building of this group to be put up. It was a 3-story structure, and had barely been finished; but it was not yet occupied when the earthquake occurred. Sections of the walls were thrown down from every face of the building. These sections extended from the eaves down to the second floor. The tower at the northeast corner was badly cracked and part of it fell. The plaster was broken on all the vertical walls, both on the outside walls and on the partitions, showing that there was much internal wrenching of the building. The walls of this building will all have to come down and be rebuilt from the foundation. (Plate 102A.)

A. Wrecked arches, Geology Building, Stanford University. Per J. C. B.

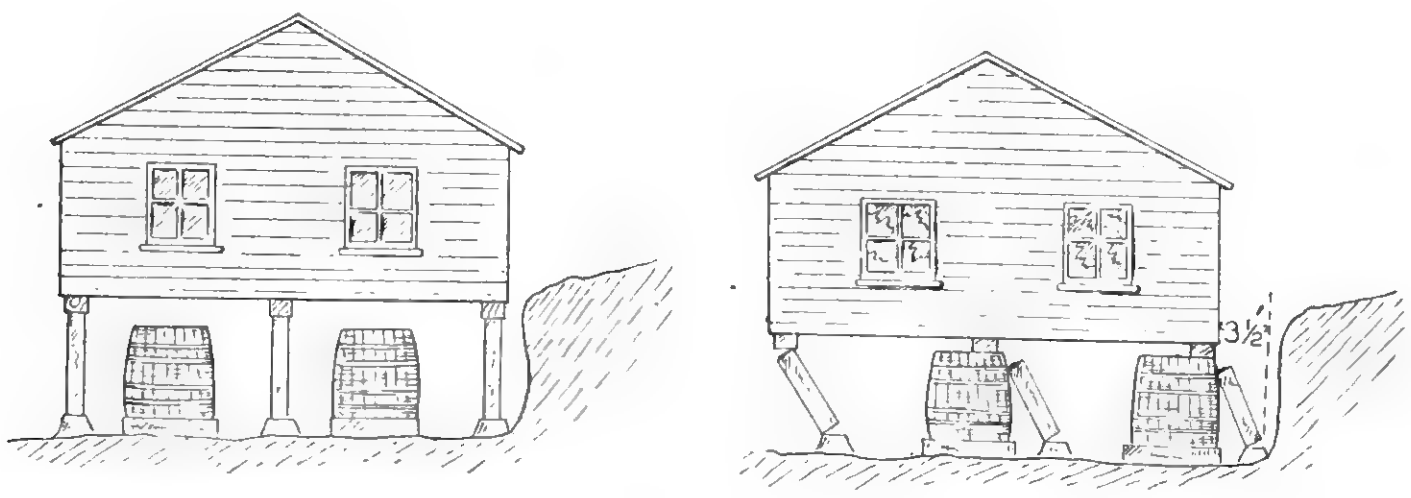
of the house was left resting upon the wine tuns, and not upon its original upright supports (fig. 56). The fence and road near the house were crost by the fault and showed an offset which indicated a relative movement of the southwest side toward the southeast (plate 64B). One fence was broken apart, but the other was merely bowed, due probably to the resistance and drag of soil occasioned by a well-packed roadbed. The fruit-tree rows which crost the fault-line at approximate right angles were put out of alinement.

Fig. 56.—Section thru winery at Morrell ranch before and after the shock.

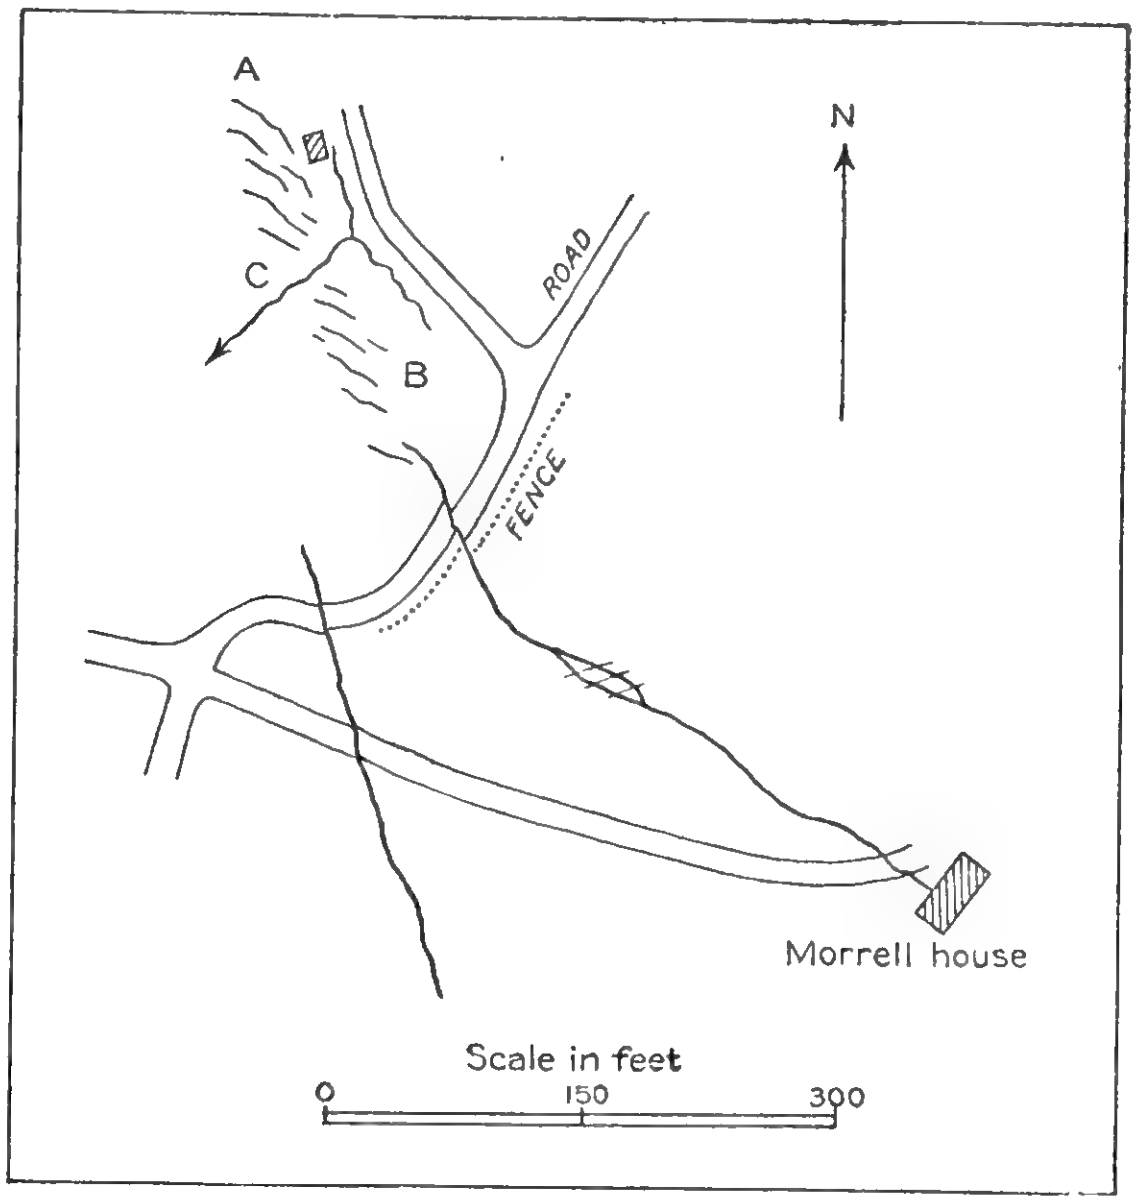
A feature associated with the movement of soil along the fault-line is shown in the accompanying sketch, fig. 57. The "splintering" of the main fracture raised a long, low ridge across which a creek had been forced to cut its way thru a vertical distance of 1.5 feet to get down to its original level.

Fig. 57.—Displacement on auxiliary crack, Morrell ranch.

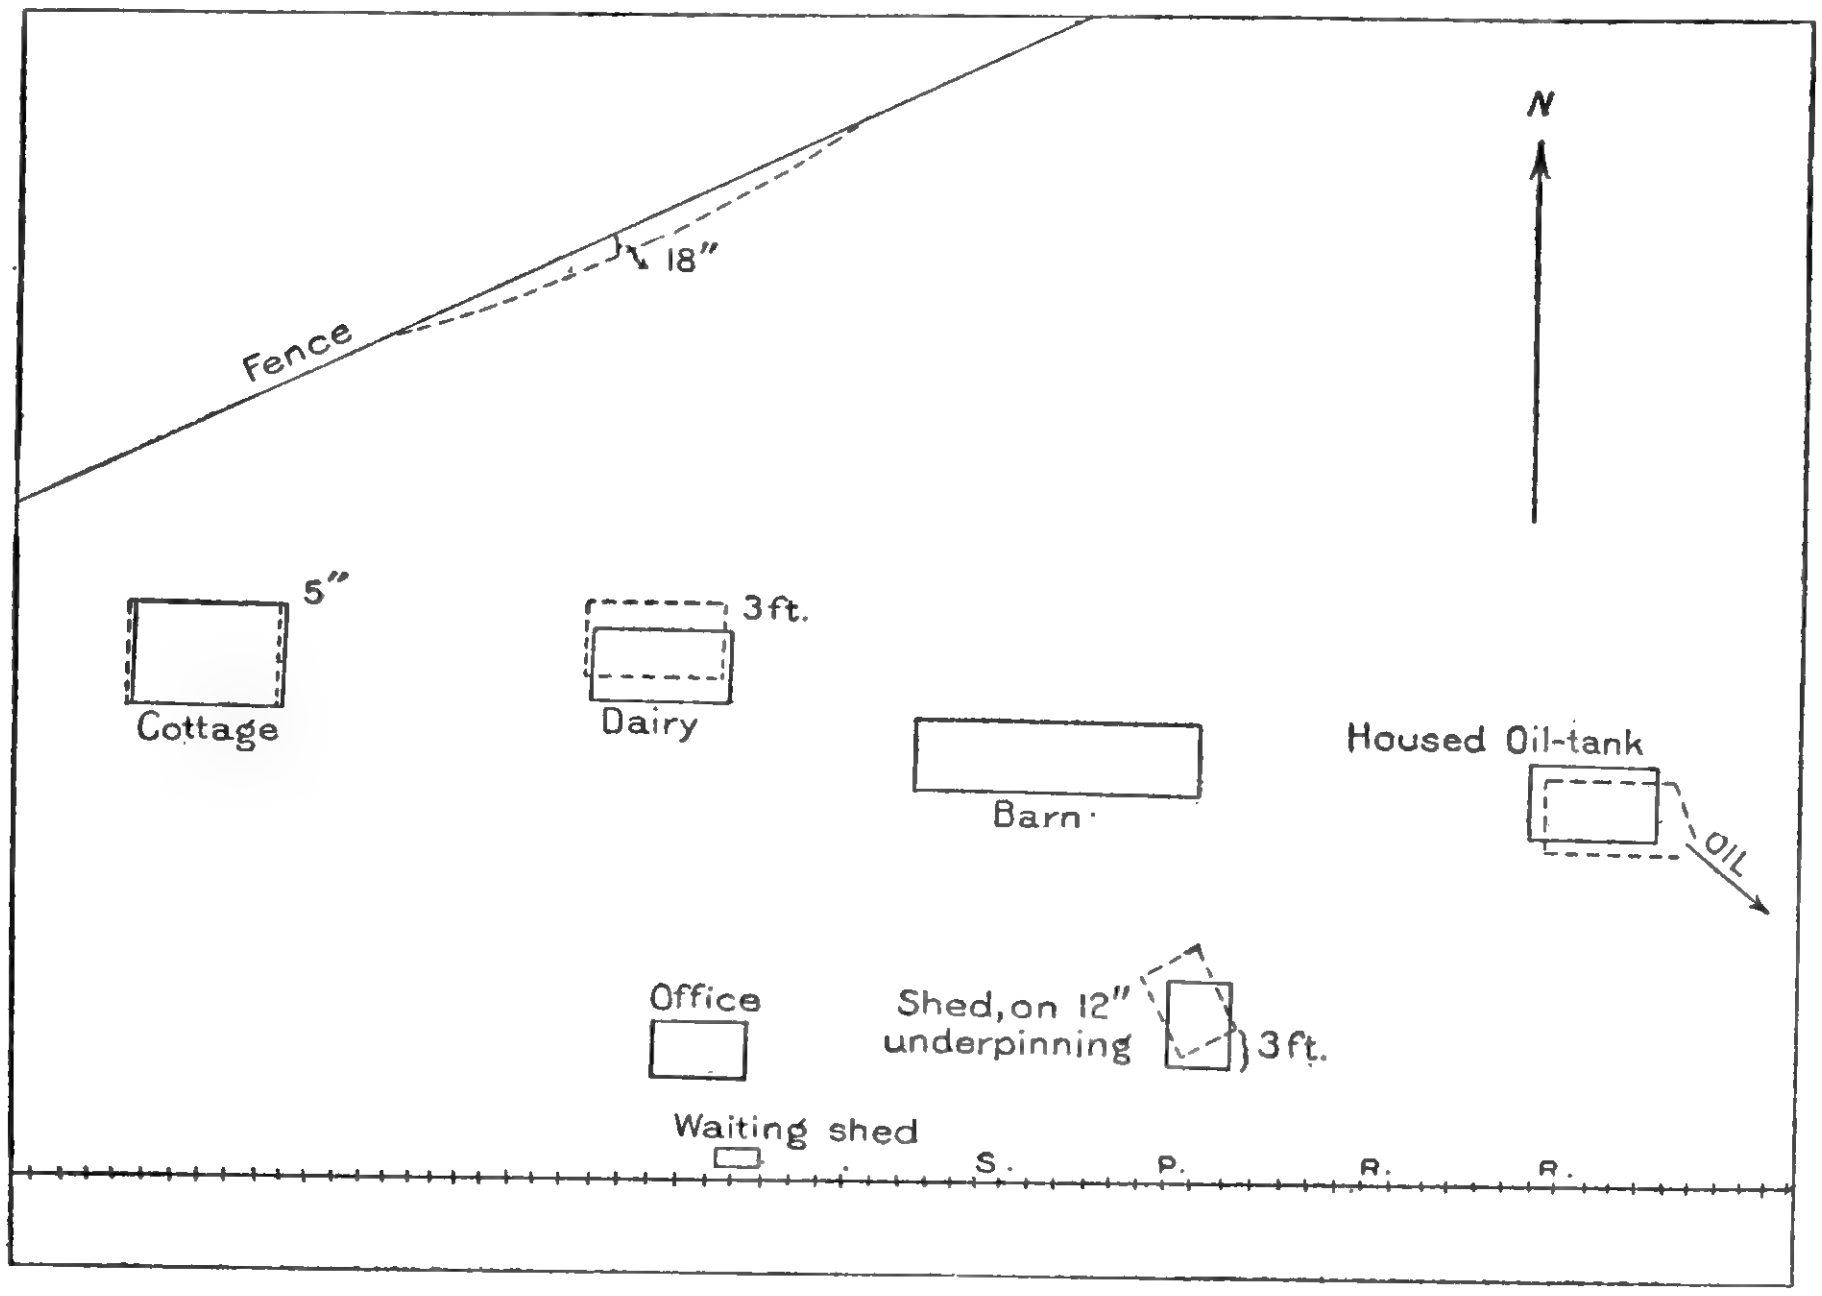
Chittenden (G. A. Waring). — At Chittenden Station evidence of a most violent disturbance was found. The cottage of the foreman was moved 5 inches westward; an upright piano was thrown northwestward upon its back, and electric drop-lights swung so as to break against the ceiling. A large frame dairy building on underpinning was moved 3 feet northward, as was a smaller building. The oil in a large tank was thrown southeastward, badly bending the tank and smashing the protecting shed. (See fig. 58.) The railroad office was not moved from its foundations, but the porch roof was jerked nearly off and a 1,000-pound safe was thrown southeastward upon its back. Three freight cars on the side-track, loaded with beans, were tipt over to the northeastward. At the time of the shock a north-bound freight train was running at about 30 miles an hour, a short distance south of the bridge over the Pajaro. About 10 cars in the middle of the train were thrown off on both sides of the track. The track at the southern end of the Pajaro bridge sank from 2 to 4 feet for a distance of 150 yards, and between Chittenden and the bridge the track was bent in an S-shaped curve in several places. The concrete piers of the bridge were cracked, and the granite cappings shifted as before noticed. (See plate 65B and fig. 43.) There is much sulfur, oil, gas, and water in the hills here. A marked increase was noted in the flow of oil and water, and more gas and sulfur became associated with them. It is said that since the earthquake 16 years ago small shocks have been felt each spring, often severe enough to crack chimneys, and a deep well becomes muddy 2 or 3 days before these occur.

FIG. 58.— Displacement of buildings at Chittenden.

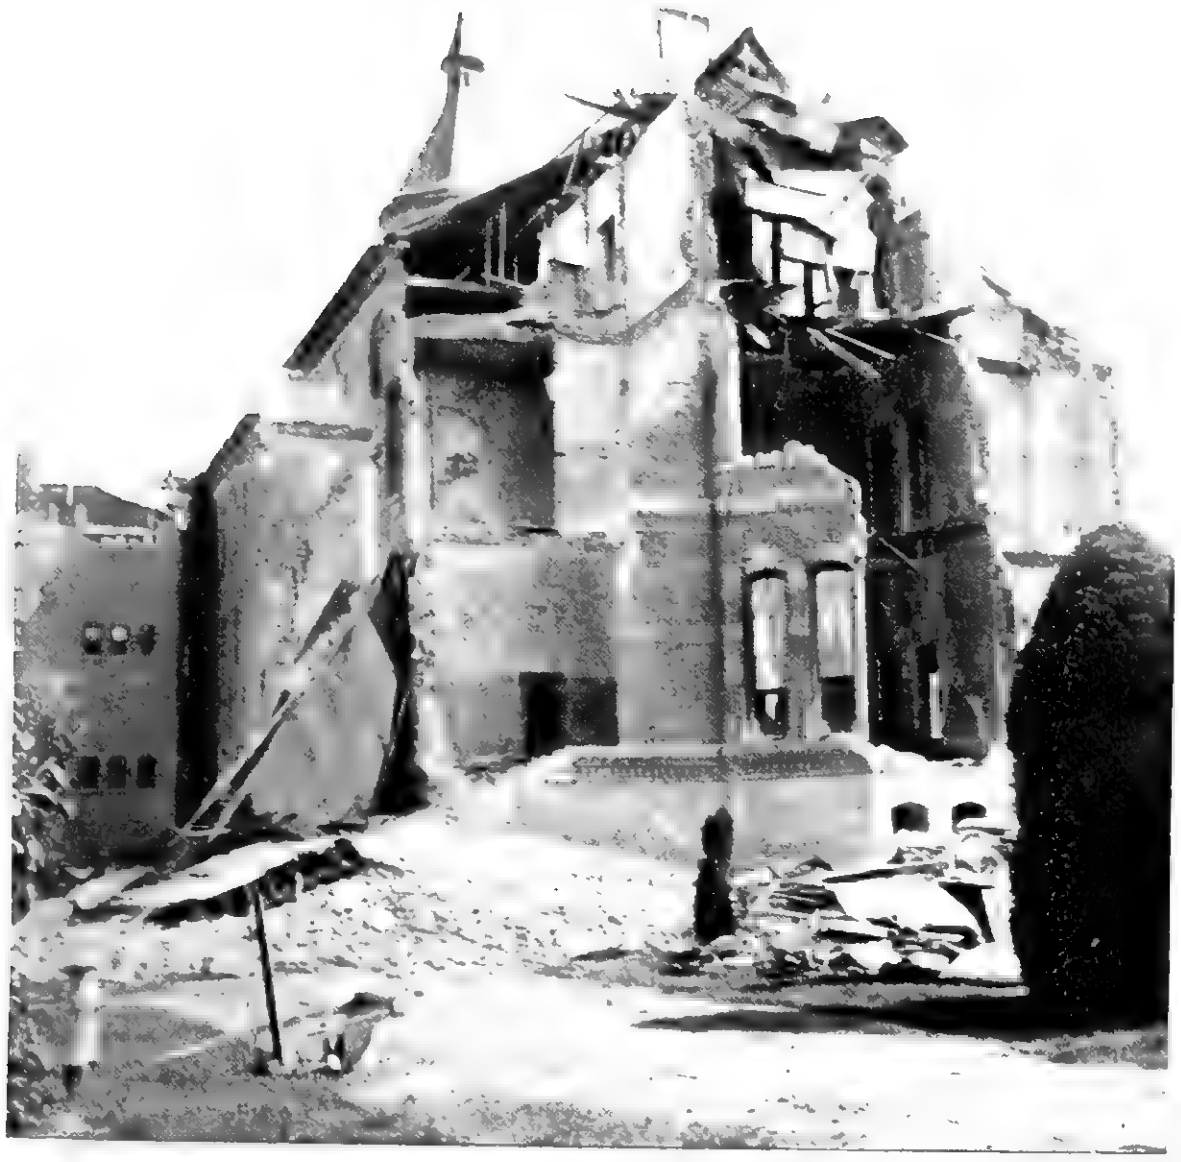
A. Agnew's Insane Asylum. North end of female wards. F. E. M.

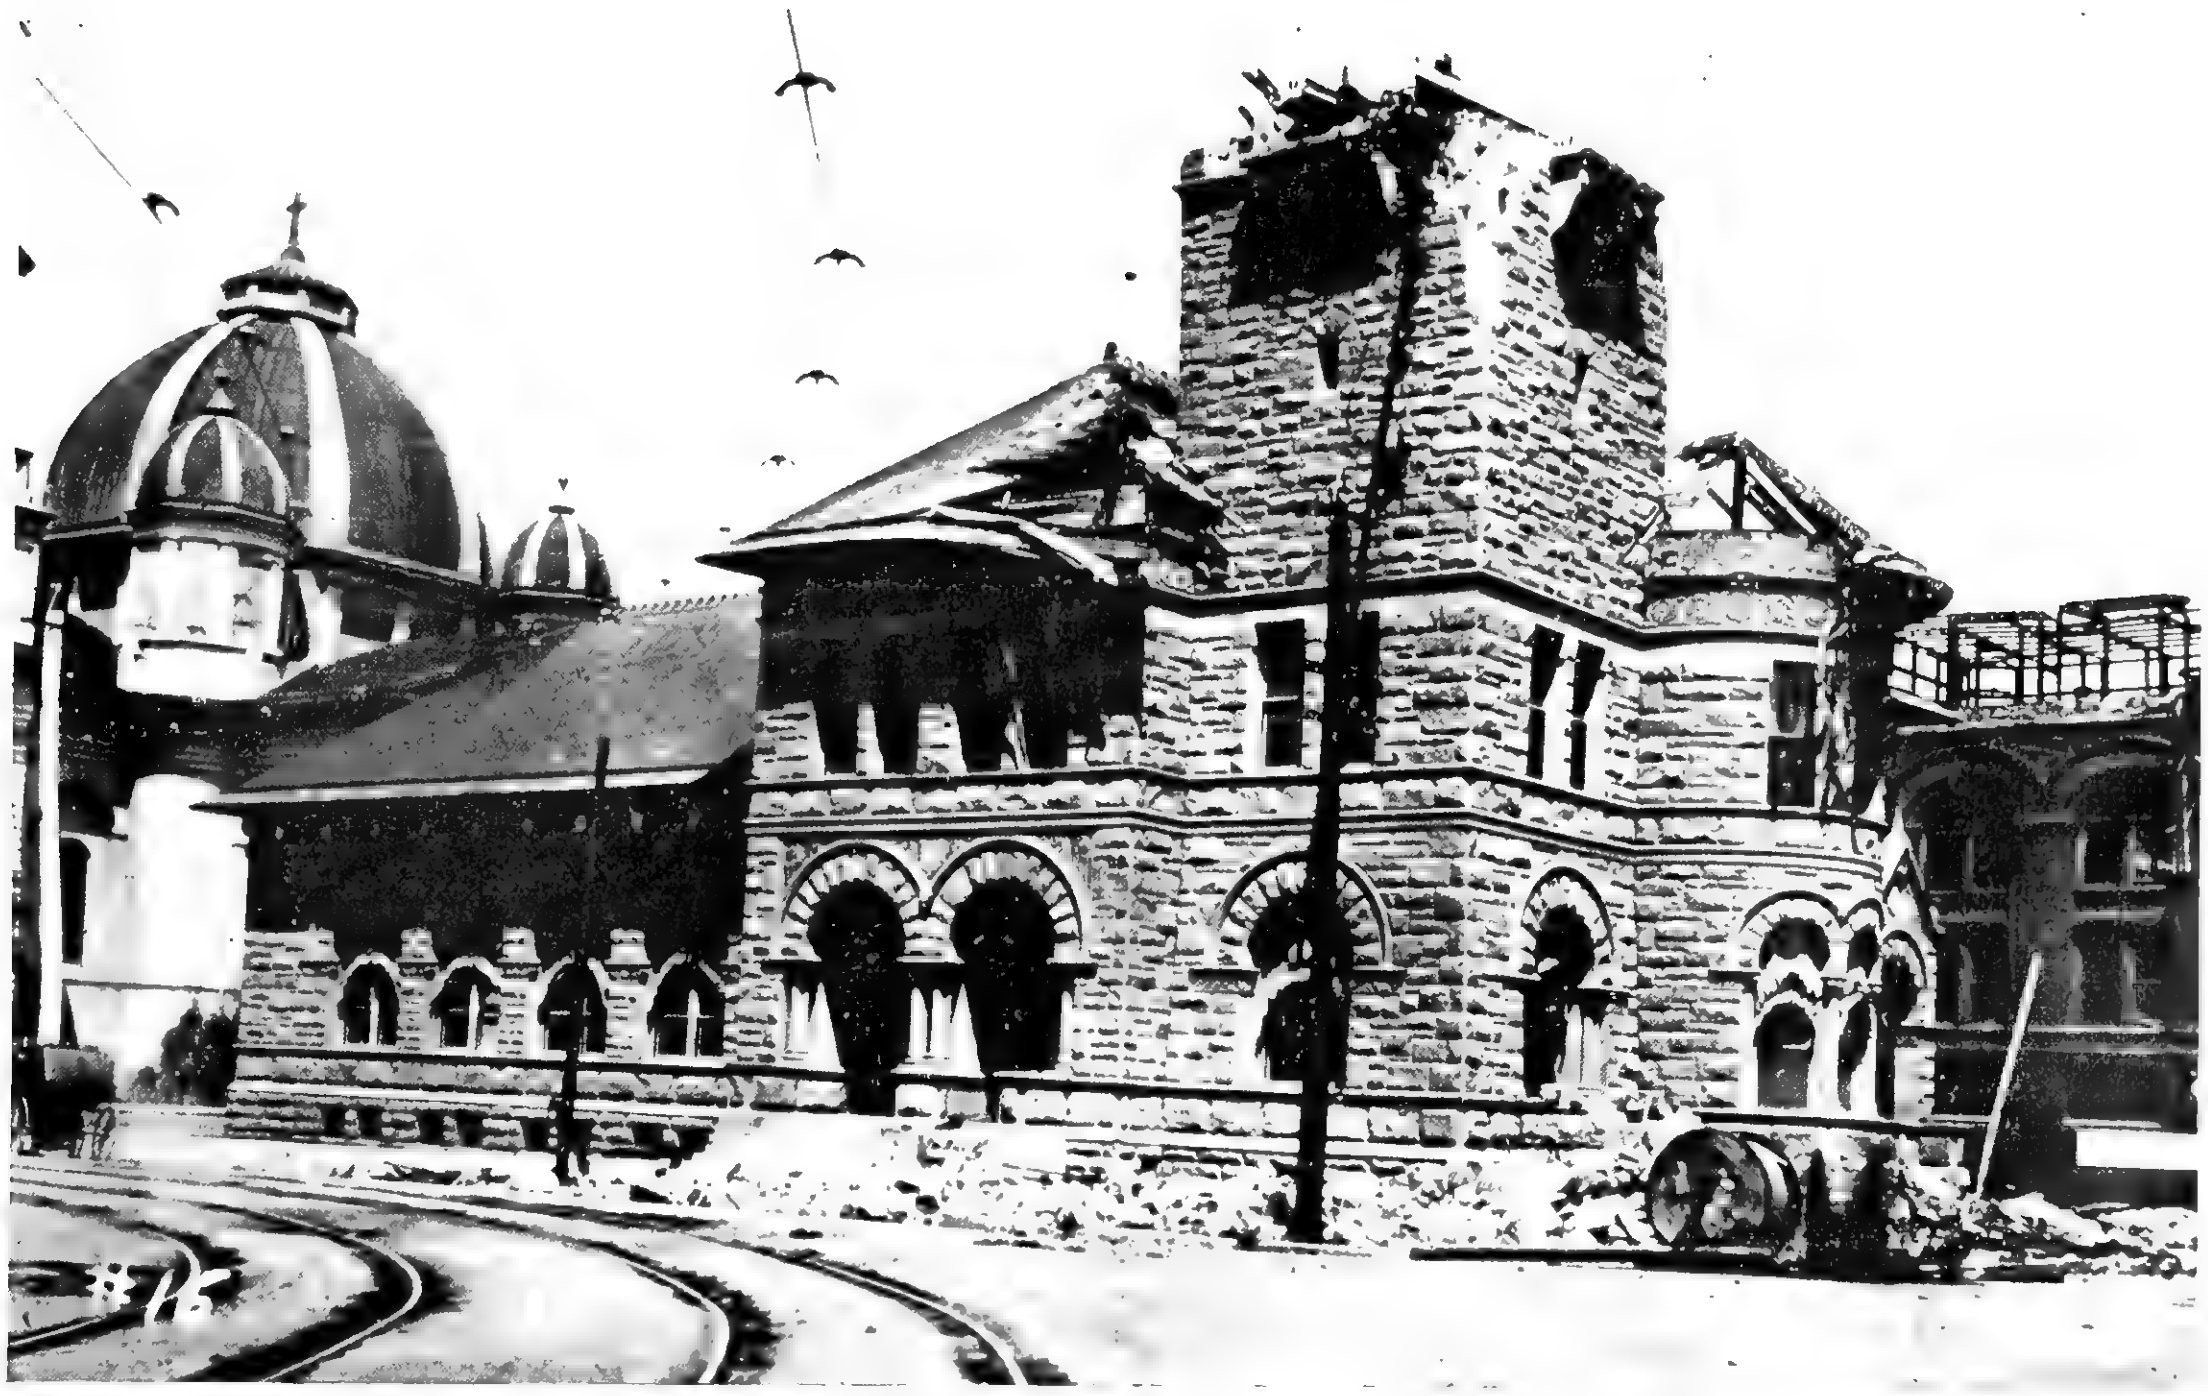
A. Post-office, San Jose.

B. Box factory, corner Fifth and Julian Streets, San Jose. A. C. L.

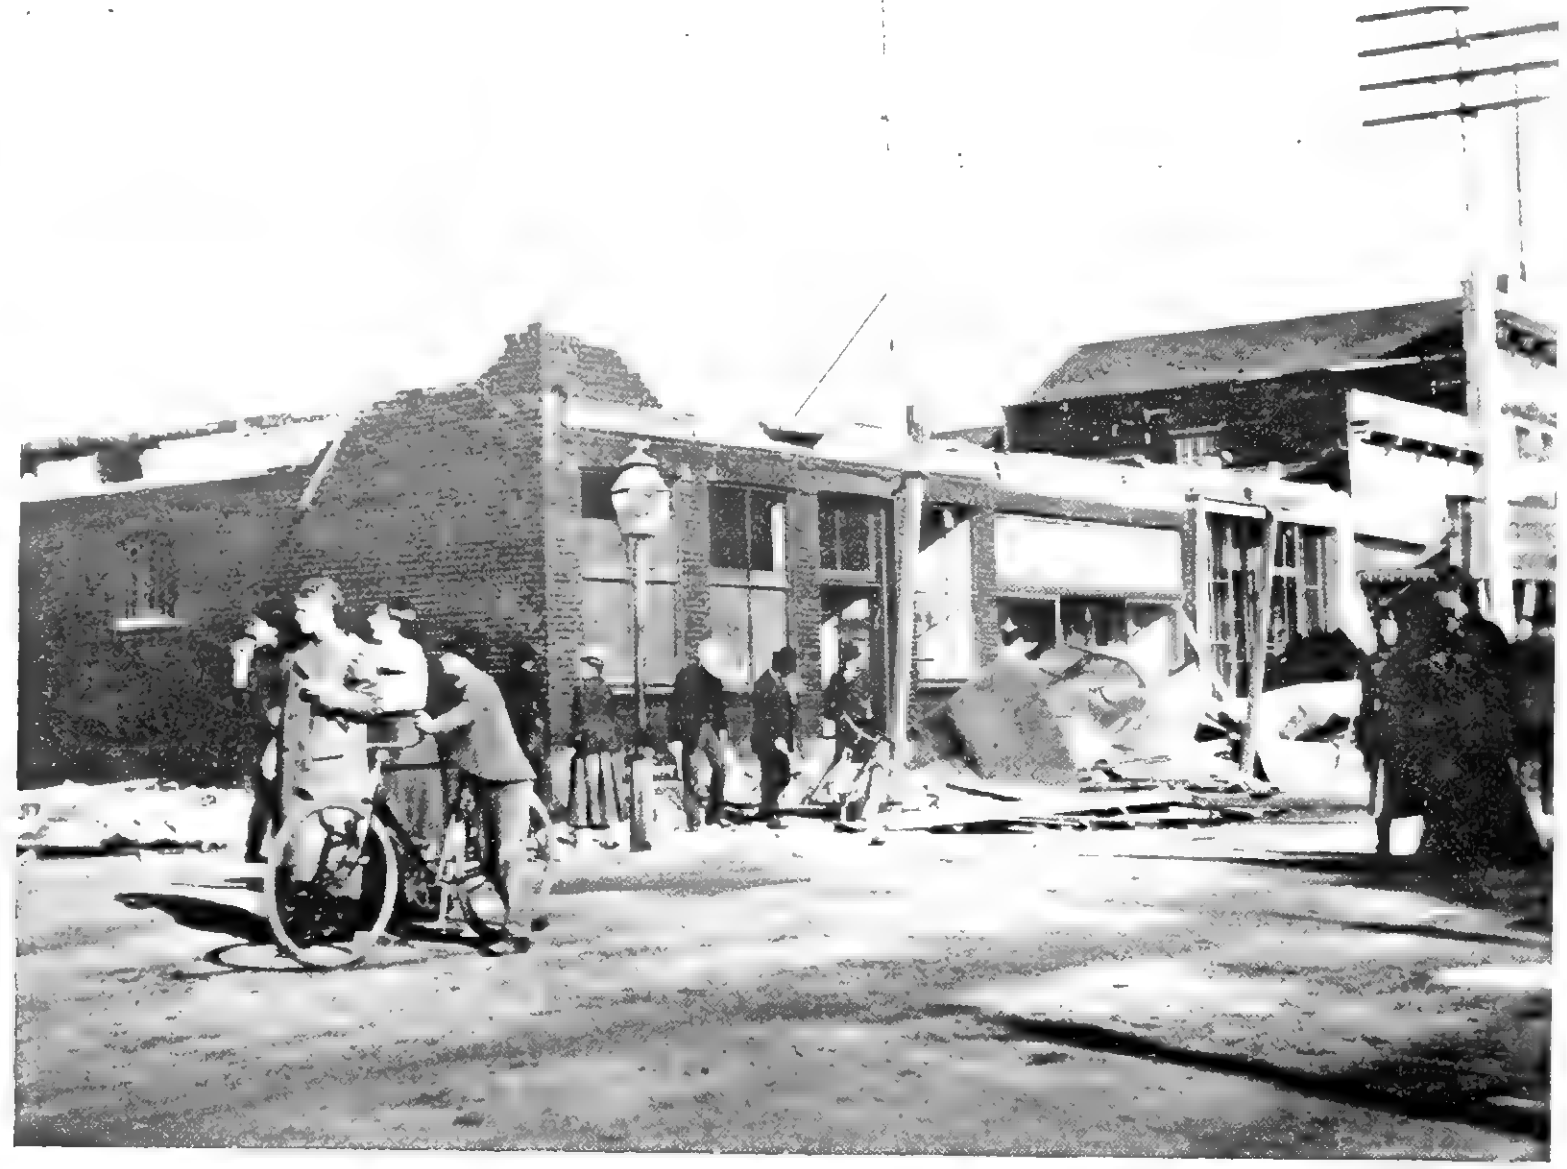
A. Gilroy.

(A. J. Champreux.)—About 90 per cent of the chimneys in Gilroy fell, the prevailing direction being east and west. No frame houses were thrown off their foundations. Brick walls were damaged at the top by the fall of 8 to 20 courses of brick. Most of the plastered houses suffered by the cracking of plaster. No cracks were found in roads or pavements. At the Cemetery, about 50 per cent of the monuments were overthrown. Of the fallen ones, 95 per cent were thrown in an east-west direction. All monuments overthrown had square bases.

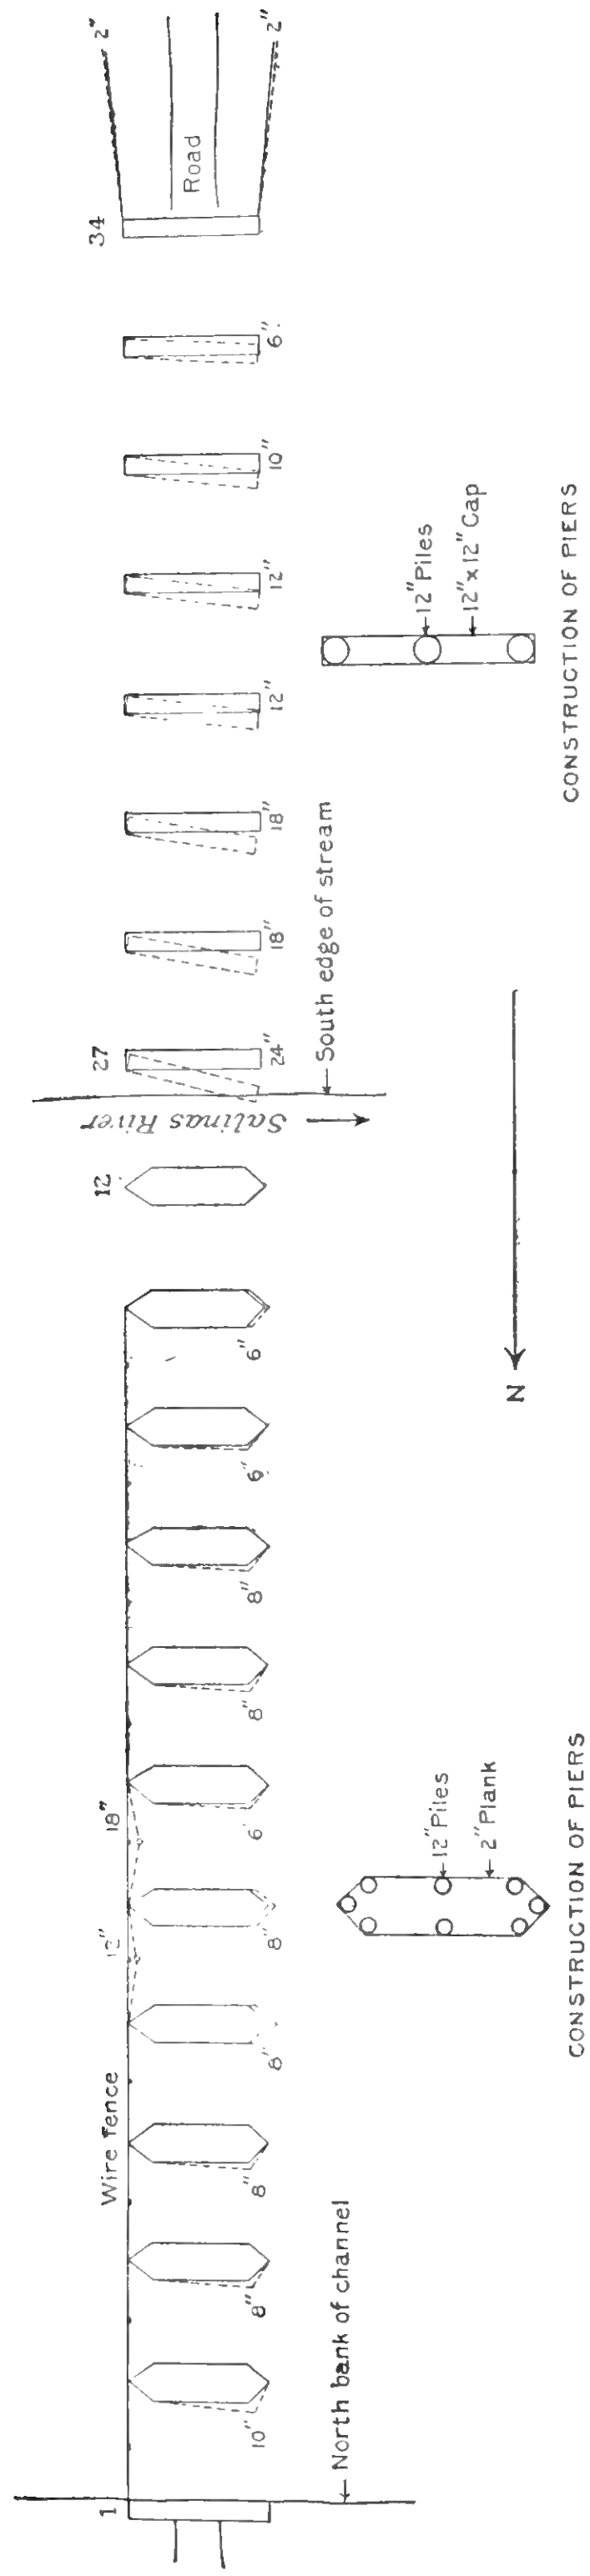
FIG. 59. — Displacement of piers of highway bridge across Salinas River, 3 miles west of Gonzales. The bridge is $\frac{1}{8}$ mile long.
